NACA RM E53G02

PRELIMINARY INVESTIGATION OF SEVERAL ROOT DESIGNS FOR
CERMET TURBINE BLADES IN TURBOJET ENGINE

II - ROOT DESIGN ALTERATIONS

By A. J. Meyer, Jr., G. C. Deutsch, and W. C. Morgan

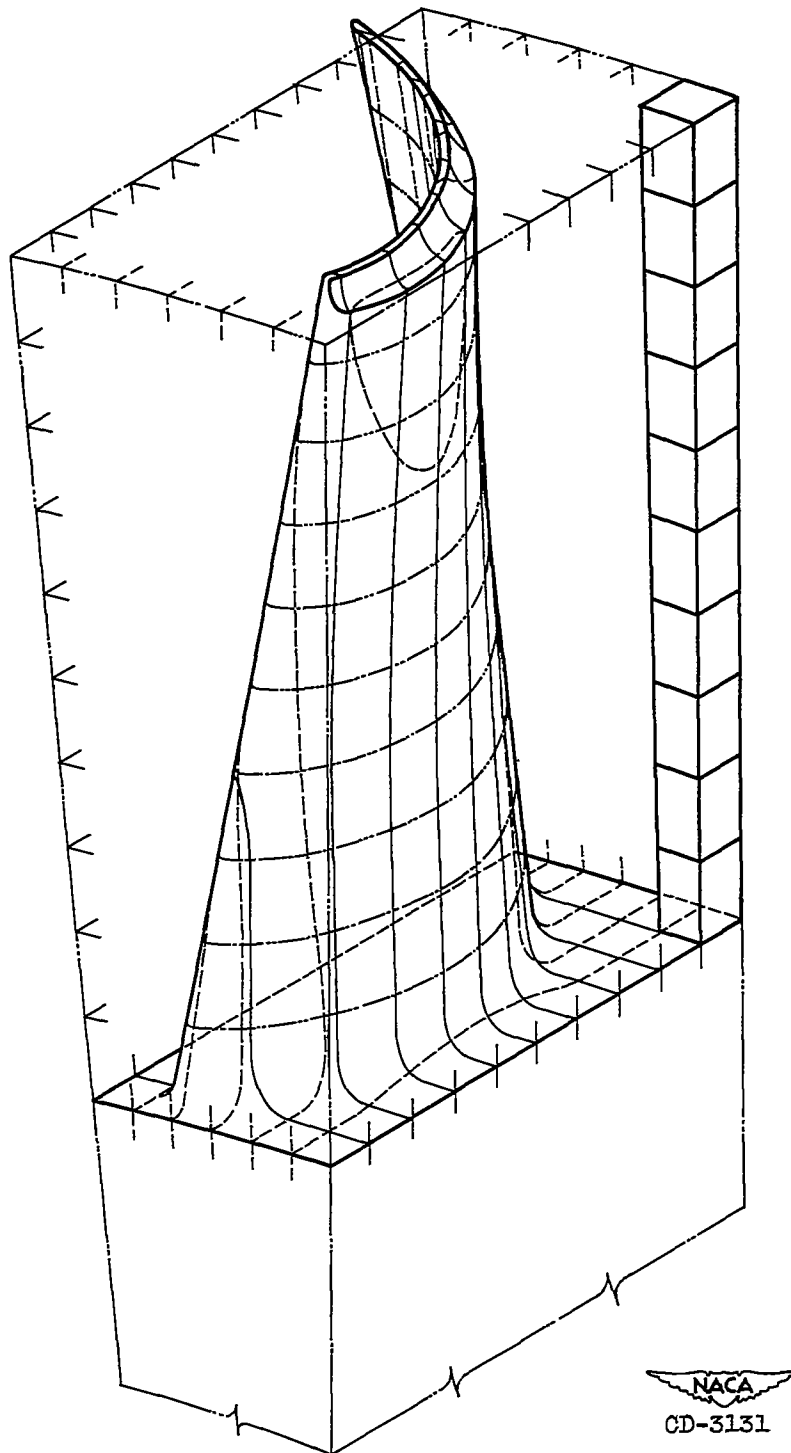
Calculation procedure. - The airfoil span or length was divided into 10 sections. The profiles of the sections were drawn to five times the size. The base profile was subdivided into small squares $1/2$ inch on a side (0.1 inch on a side at actual blade size.) All other profiles were correspondingly subdivided into rectangles $1/2$ inch in the direction of the turbine wheel axis and slightly greater than $1/2$ inch in the tangential direction. The correction in tangential distance is due to the increase in chord length of a radial segment as the radial distance increases, as sketched diagrammatically in figure 9. The volumes of the small airfoil pieces between corresponding rectangles of each station were calculated and totalled. The centers of gravities and the radial distances of the resulting long thin radial columns were computed to permit calculation of the centrifugal force acting on each square of the base airfoil profile due to its respective column.

Figure 9. - Sketch showing airfoil divisions for computation.
